**AUTUMN 2012 ENA  
SHE MANAGERS  
REVIEW OF PAST ASSET  
RELATED INCIDENTS**

## SHE REVIEW – AUTUMN 2012

## INTRODUCTION

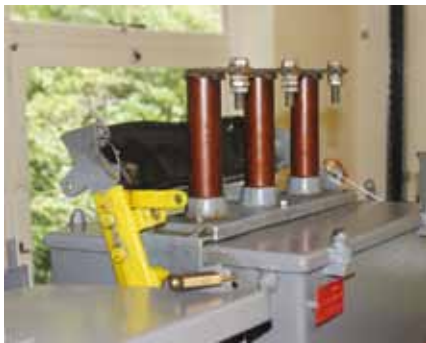
Some of the worst incidents the industry has experienced have involved problems with the test prods used to test cables connected to HV Ring Main Units (sometimes known as test plugs).

These incidents can be very severe because the insulating oil can be ignited by any flashover, leading to a fireball. These prods are designed to be used safely in tanks which may have live conductors in them. They rely on a correct fit to guide them, so correct use of the right prods, in good condition, is critical.
